REPORT DOCUMENTATION PAGE		READ INSTRUCTIONS BEFORE COMPLETING FORM
1. REPORT NUMBER	2. GOVT ACCESSION NO. AD-A130646	3. RECIPIENT'S CATALOG NUMBER
4. TITLE (and Subtitle) FOUNDATION REPORT (ON) CONWAY WATER SUPPLY DAM, ARKANSAS		5. TYPE OF REPORT & PERIOD COVERED Final Report, 1980 - '82

FOUNDATION REPORT

June 1983

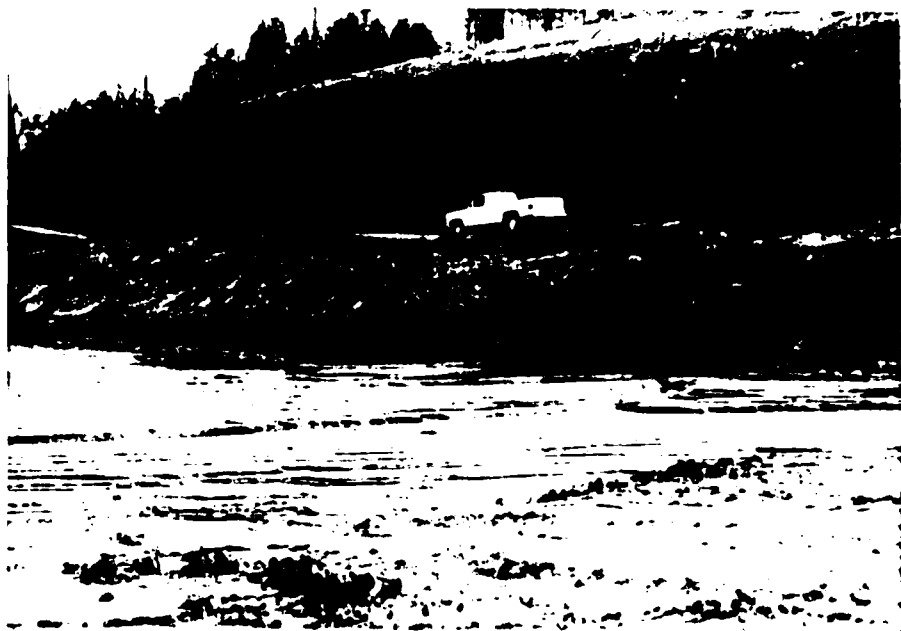
24 Mar 81. Conway Water Supply Photo No. 7

View southwest showing foundation rock: exposed along dam axis from Stations 12+40 to 11+75, left to right. Note joints in right abutment in background. Rock is Atoka Shale.

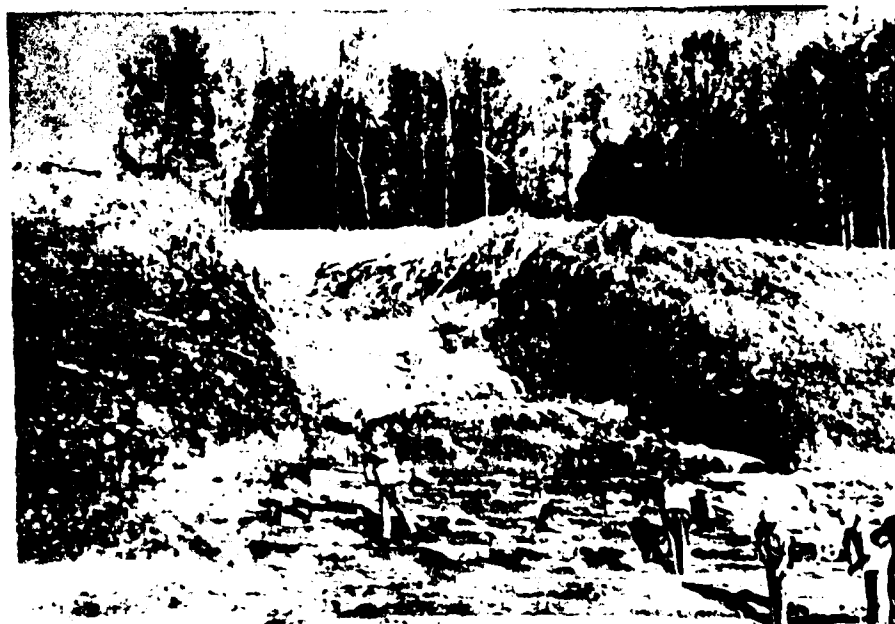
6 Nov 80 Conway Water Supply Photo No. 11

View east toward left abutment core trench showing exposed foundation rock along dam axis between Stations 16+20 to 16+58. Note concrete fill along rock ledges of Ato'a Shale.

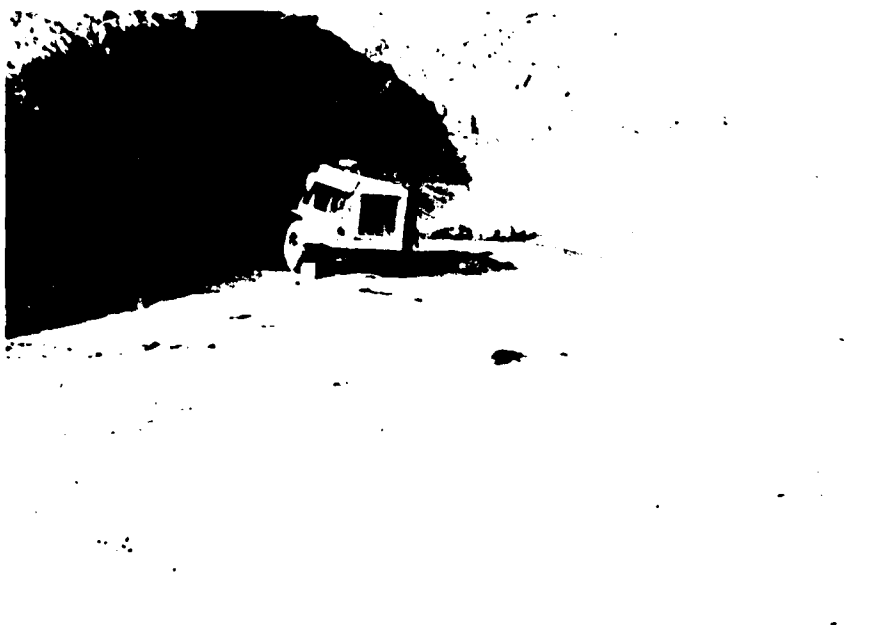
10 May 82 Conway Water Supply Photo No. 15

View northeast showing exposed foundation rock  
along dam axis between Stations 17+57 and 18+18.  
Note curve in core trench along dam axis. Rock  
is Atoka Shale.
